H-D FIVE-SPEED TRANSMISSION

Part II: Common glitches and their fixes

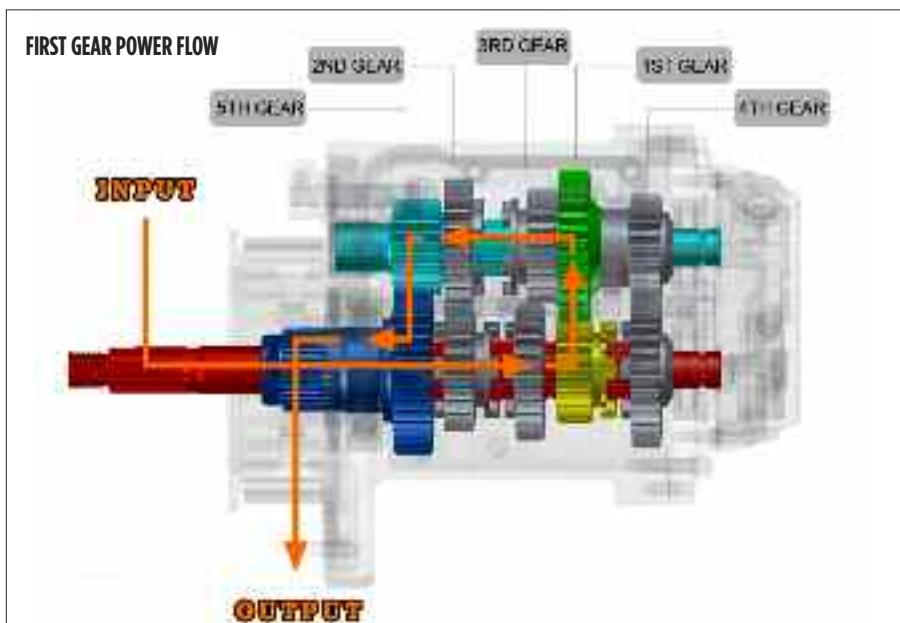
HOW IT WORKS

transmits the power flow through the first gear pair, as shown in the power flow illustration below.

The Harley-Davidson Big Twin five-speed transmission is a constant mesh design, meaning all five gears on the mainshaft are always in mesh with their respective gears on the countershaft. Each gear pair has one gear that's splined (locked) to the shaft while its mating gear, called a speed gear or idler gear, on the other shaft rides on a needle bearing. For example, let's look at the power flow when first gear is engaged. First gear on the mainshaft is splined to the mainshaft and first gear on the countershaft spins freely on the countershaft on a needle bearing. Third gear on the countershaft is splined to the countershaft and is located adjacent to first gear on the countershaft. When the shift fork moves third gear over to first gear on the countershaft and engages the dog teeth, first gear on the countershaft is coupled to the countershaft and

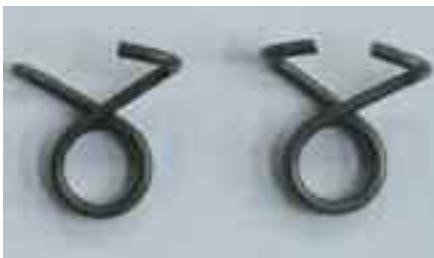
The question is not if the stock 1979-2000 return spring will break; it's a matter of when. The left arm of the spring on the left has broken off.

In 2000, the Twin Cam Softail was introduced with a new ratchet pawl, which completely corrected the problematic shortcoming of the previous ratchet pawl spring and also provided overshift protection. To prevent an overshift, a beak was integrated with the new-style ratchet pawl arm, which guaranteed that a first-to-third gear upshift didn't occur when an aggressive first-to-second shift was attempted. In 2001, the new ratchet pawl was used on all Big Twins.

Generally, it's not a matter of if the 1979-2000 style return spring will break; it's a matter of when. The rider will know when the spring breaks because the foot shift lever will not return after a shift is made, and the lever will be floppy as if something in the shift system came loose. When this occurs, do not ride the bike any farther because the broken piece of spring will be migrating around in the transmission waiting for a chance to get churned between a gear pair, destroying the transmission. The H-D new-style ratchet pawl is not easily retrofitted into the older bikes because a longer case sleeve bushing, top cover, shift drum, and pillow block are required for that transformation. And the new-style detent spring has shortcomings as well, as we will discuss later. However, if you take preventative maintenance seriously, the aftermarket offers a ratchet pawl that incorporates the new-style return spring, with overshift protection, that retrofits into the existing 1979-2000 transmission without the need to change any other parts.

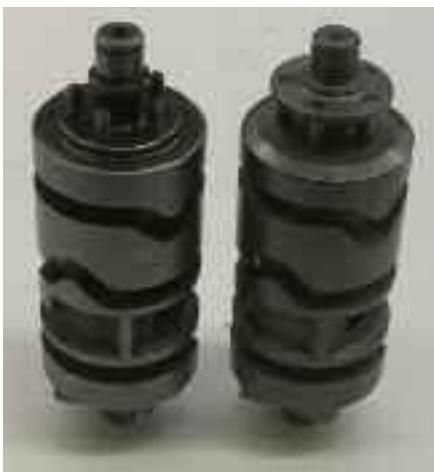
A shift drum with unsupported 4mm pawl pins is on the left; a supported drum is on the right.

The new-style roller detent shift drum was introduced on the 2000 Softail. The unsupported 1/4" pawl pins of the previous design were replaced with smaller unsupported 4mm pawl pins, which were prone to breaking. Within that first year of production, the factory upgraded the design with an outside support for the 4mm pawl pins and the problem was solved.

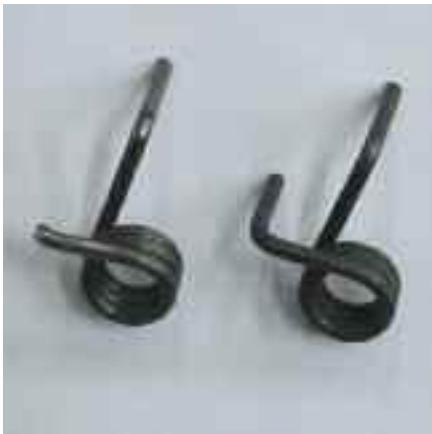
As you can see, the arm on the 2000-06 Softail detent spring on the left is broken. A complete spring is on the right.

Starting with the 2000 Softail, the factory replaced the plunger detent with a roller detent to improve shift quality and all 2001 models used this configuration. Unfortunately, the design of the detent spring, and the failure mode, is similar to the 1979-2000 ratchet pawl spring in that the cantilevered leg of the spring breaks off over time. The broken spring leg makes itself known when the foot lever lacks any detent feel. As with its predecessor, the broken piece of spring can cause transmission damage. The only solution for this is to replace the spring at 30,000-mile intervals or replace the whole shift drum detent assembly and ratchet pawl with an aftermarket version.
