ROADMAX™ 6 SPEED VS. BAKER™ 6 SPEED

By Pete Benschoter

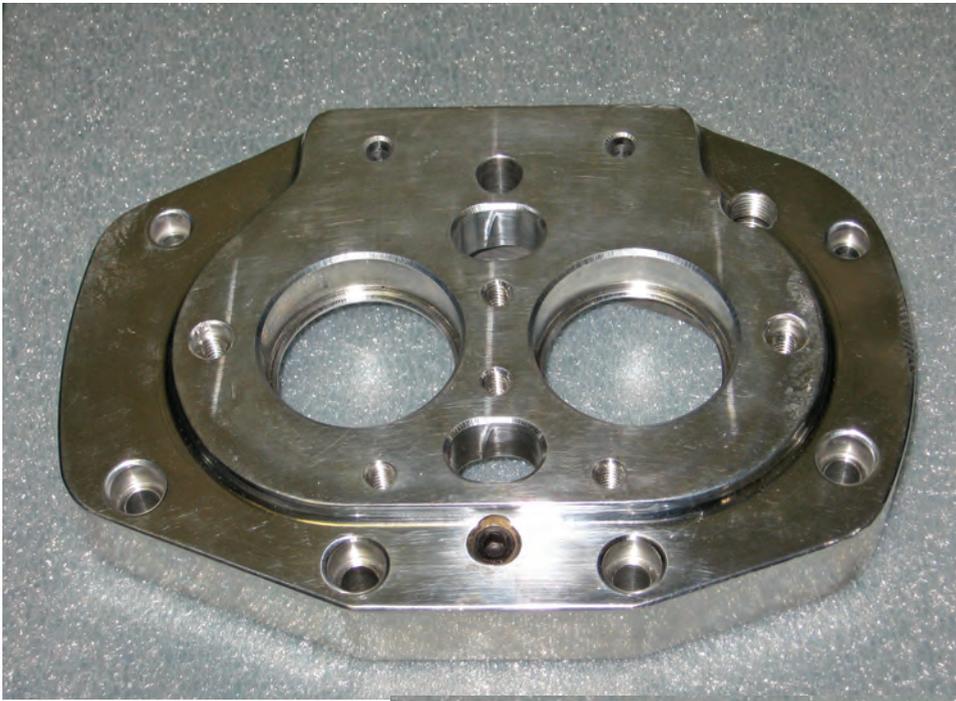
Roadmax Bearing Door

Note the mismatch of machining in the 2 center oiling ports. The dowel hole for the left most side cover hole would cause a lack of full thread engagement and possible stripping in the future. Though this door did not show signs of thread stripping or side cover movement. Check out the hardware store drain plug with pipe dope.

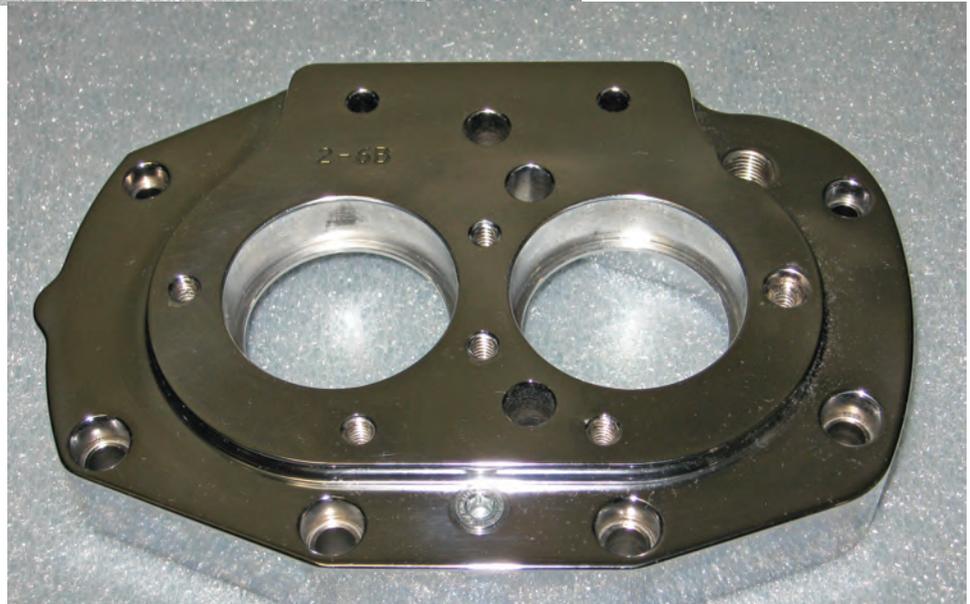
Baker Bearing Door

Note the 2 offset drilled oiling holes to clear the 6th gear on the mainshaft. The lack of a left side dowel should be overcome by having 6 fasteners with full thread engagement. No sign of side cover movement on this door. Check out the aftermarket drain plug with built in o-ring.

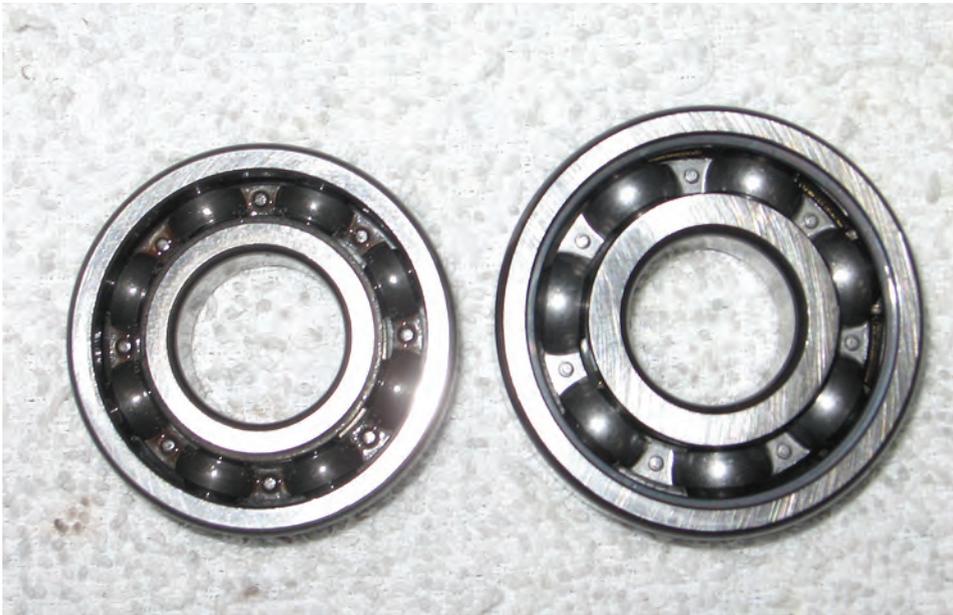
Trap Door Bearings

Both the 6204 on the left and the 6304 used riveted together steel cages for strength. You can see from the picture the difference in the size of ball bearings that can fit within the races of the larger 6304.

Another contrast in design that I observed was the choice of bearings and the resultant press fit in the door. The Baker 6 Speed used 6304 single roller bearings, whereas the Roadmax 6 Speed used 6204 single roller bearings. What does one number and 5 mm bigger diameter matter? More than you would think. The 6204 bearings were

used in the bearing door for all stock 80" EVO transmissions, whereas the 6304 bearings were used in the bearing door of all TC88 transmissions. This is due solely to the 20% higher dynamic load ratings for the 6304 bearings. The bigger the outer diameter of a roller bearing, the bigger diameter the ball bearings you can stuff in them, thus increasing the load carrying capacity. If the Factory didn't think that the 6204 bearings would hold up to an 88" emissions motor, then one can't possibly think that a hot rod'd 96" will fair much better.
